PROPERTY SAMPLE SURVEY
NOT FOR DISTRIBUTION
EXAMPLE TEXT ONLY
AB12 3CD

SURVEY DATE 1 Sep 2018

BUY-TO-LET SURVEY REPORT

INCLUDING CONDITION and HEALTH & SAFETY REVIEW

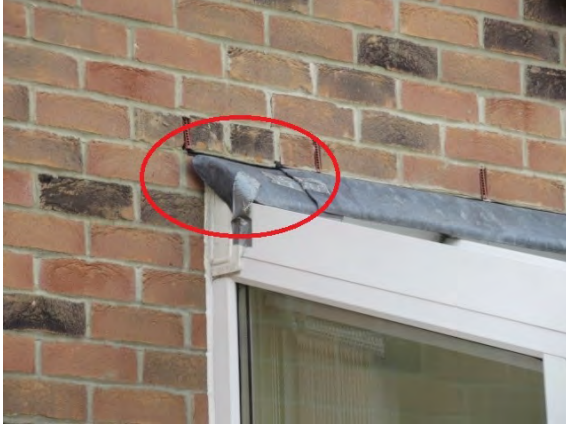
<p>Front and right side roof pitches</p>	<p>Right side roof pitch</p>
	<p>Loose and taped flashing for the living room extension roof at the back</p>	<p>Roof Elements</p>

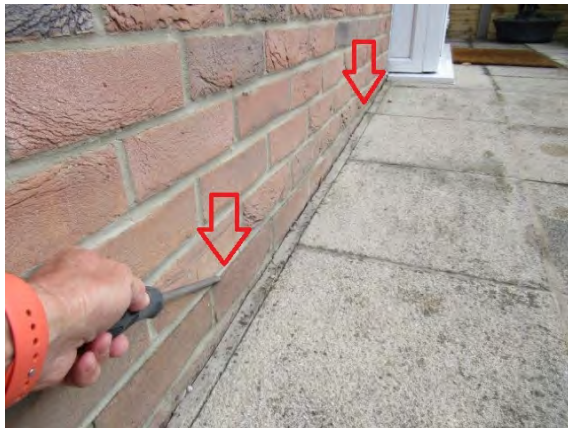
Level of damp proof course at the front is below the paving around the front porch viewed from the front

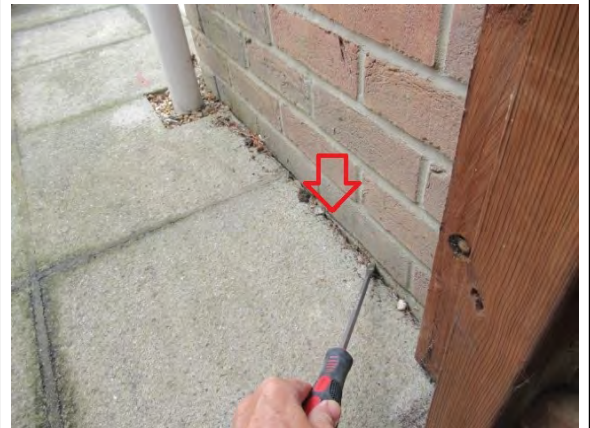
Level of damp proof course on the right side adjacent to the porch

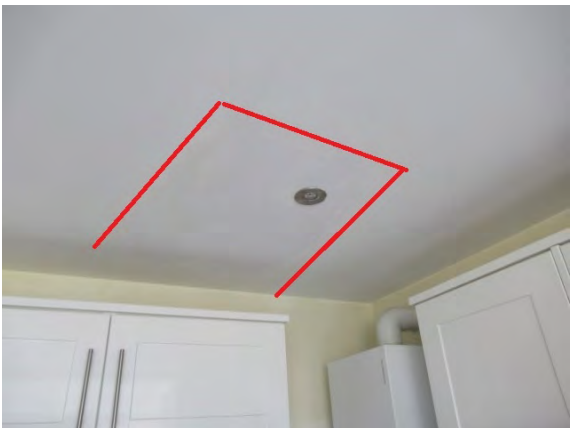
<p>Condition</p>	<p>No significant defects were noted. No evidence was seen of any unusual unevenness, cracking, bowing or other failure. A stain on the kitchen ceiling, near to the boiler, is immediately below the en-suite shower room. The sellers indicated that the stain was caused by water escaping from the shower after the door was left ajar. While it is assumed that this is a genuine explanation, of course, it cannot be confirmed. However nothing was seen to suggest that this is an ongoing matter.</p> <p>Some cracking of the ceiling finishes was noted. These cracks are primarily along the lines of plasterboard joints and are unlikely to be symptomatic of undue movement of the property.</p> <p>Normal maintenance is required, including filling and redecorating cracks as necessary.</p>

<p>Staining in the kitchen near to the boiler</p>

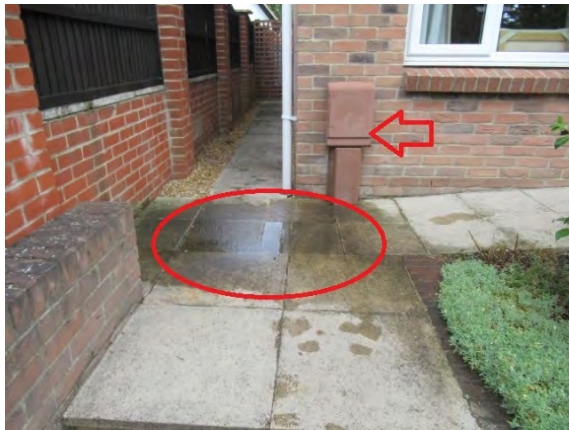
Condition	<p>At the front of the house a wet area was noted on the paving in the area immediately in front of the water meter housing. This could be caused by a leak from the main water supply to the house. If this were the case then a leak of this type can lead to the ground beneath becoming unstable, causing the house to subside as the foundations fall into the ground which has been washed away.</p> <p>The sellers indicated that they had had the installation inspected by the water authority and that it had been confirmed that the wetness was not due to a leak but it was an area which took longer to dry after rainfall. Indeed, it had rained in the days prior to the survey inspection which could corroborate this version of events.</p> <p>However, as it is impossible to confirm this to be the case, from a single inspection of the property, further investigation is recommended, initially by enquiries of the sellers, until it can be satisfactorily proven that no leak is present.</p> <p>These enquiries are considered to be of an urgent nature and should be carried out before exchange of contracts.</p> <p>If it is the case that the wetness is simply due to rainfall, then some further inspection should be made to identify the pathway by which rain runs off surfaces above this area to identify whether some other factor may be causing it.</p> <p>In all other respects the installation was found to be in a serviceable condition. Hot water was obtained from all hot tap outlets, and the flow of water was found to be within a normal range.</p> <p>Check the installation for evidence of leaks or other defects on a regular basis i.e. approximately every 6 months, or sooner. Leaks most often occur at pipe joints and where pipes are subject to movement or physical damage, such as airing cupboards, roof spaces and under sinks.</p>

Wet path adjacent to water meter housing

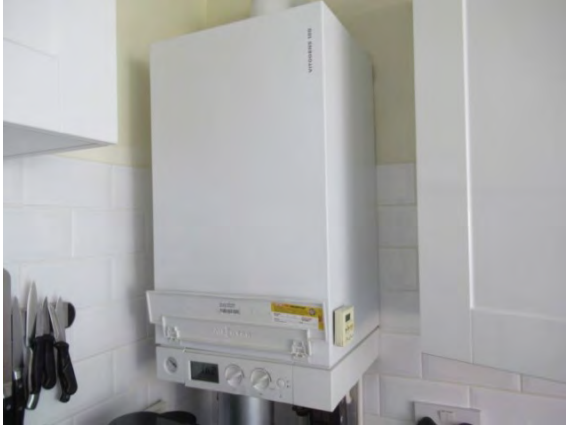
<p style="text-align: center;">Boiler</p>

<p>Condition</p>	<p>No evidence was available to suggest that the boiler has been recently serviced. However, the sellers indicated that it was due to be serviced in the days immediately following the survey inspection. The boiler is that which was installed at the time of construction of the house, and so is around 7 years old. Under normal circumstances a modern boiler will last for 15-20 years before requiring replacement.</p> <p>Gas Safe recommends that all gas appliances and boilers are inspected and serviced according to manufacturer's guidance, but at least once a year. A gas installation can look to be in a safe condition, but serious defects may be hidden, some of which can kill. It is therefore considered to be essential that you commission an inspection of the gas/heating installation prior to purchase of the property, unless you are provided with verifiable evidence that such an inspection has recently been carried out by a competent person. You can get more information, or find a Gas Safe registered engineer https://www.gasaferegister.co.uk/find-an-engineer/</p>
