Mi HOME CONDITION SURVEY

HOME CONDITION SURVEY

PROPERTY 12 Anyroad Close
Sometown
AB12 3CD

SURVEY DATE 16 Jul 2018

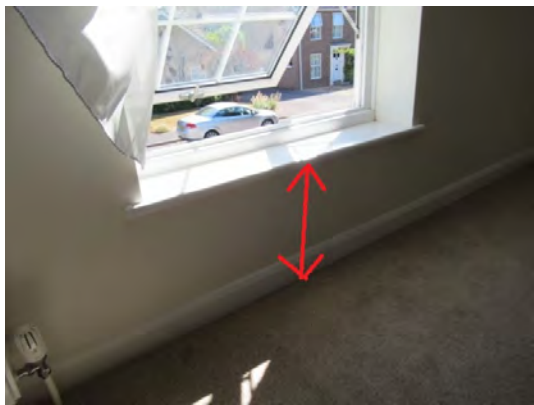
3.2 - Health & Safety related matters	
Fire Risk	Although fire alarms are fitted at the property they have not been tested. You should ensure that there are sufficient devices fitted at the property and that they are all in good working order.
Safety Glass	No issues were noted by the Surveyor.
Lead Pipes	No issues were noted by the Surveyor.
Risk of Falls	<p>Window sills on the first floor are low to the floor for example in bedroom 1, increasing the risk of falls, especially for the very young. You should consider fitting window opening restrictors.</p> <div style="text-align: center;">

<p style="margin: 0;">Low sill in bedroom 1</p> </div>
Unsafe Fittings	No issues were noted by the Surveyor. Fittings within the property, where possible, were checked for normal everyday use, but have not been inspected or tested for safety purposes.
Insect and Rodent Infestations	No issues were noted by the Surveyor.

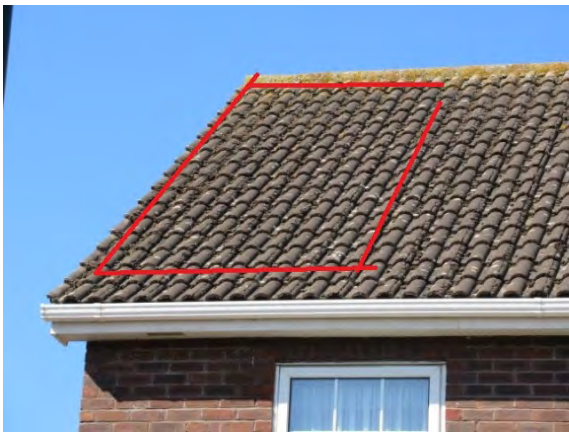
<p>Moss growth on the front roof pitch</p>

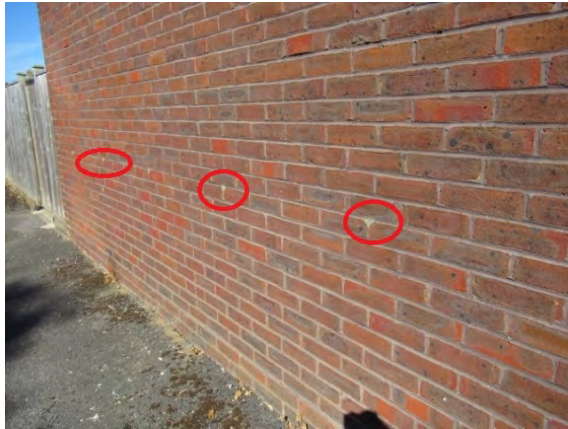
Cavity Wall Insulation drill marks

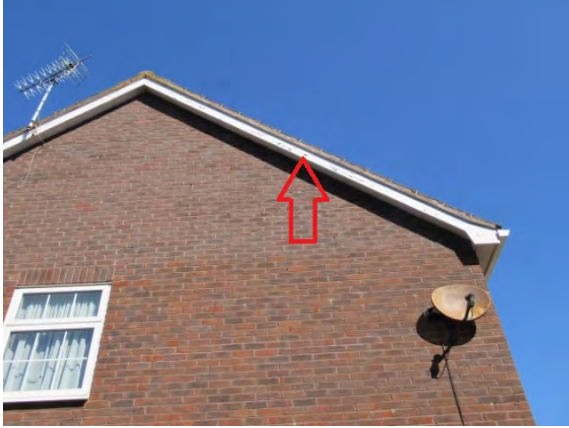
<h2 style="margin: 0;">4.6 External Joinery and Finishes</h2>		Condition rating	2
<p>Construction & Type and Limitations</p>	<p>This includes such items as woodwork at the roof edges, trim panels and any timber porch/canopy. Soffits are the horizontal timbers joining the fascia boards to the house walls. Fascia boards are the vertical timbers to which the gutters are normally fixed. Barge boards are the diagonal boards at the roof edge on the gable end of the house.</p> <p>All such materials were examined from ground level and with the aid of binoculars from vantage points within the grounds of the property and suitable public areas around. Decorations were examined for indications of poor maintenance, rot and other defects.</p>			
<p>Condition</p>	<p>No significant defects were noted. However, the joinery is in a poorly maintained condition requiring stripping and redecorating to all sides of the property. In such circumstances, many new owners would consider replacing the existing fascias, soffits and bargeboards with low maintenance PVC.</p>

<p style="text-align: center;">Poorly maintained bargeboards on the left side</p>

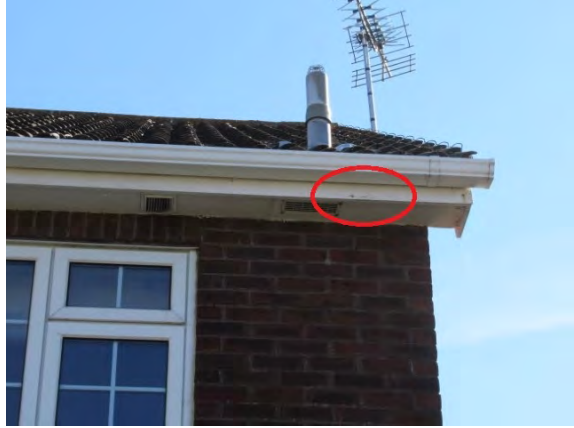
<p style="text-align: center;">Poorly maintained fascia at the back</p>

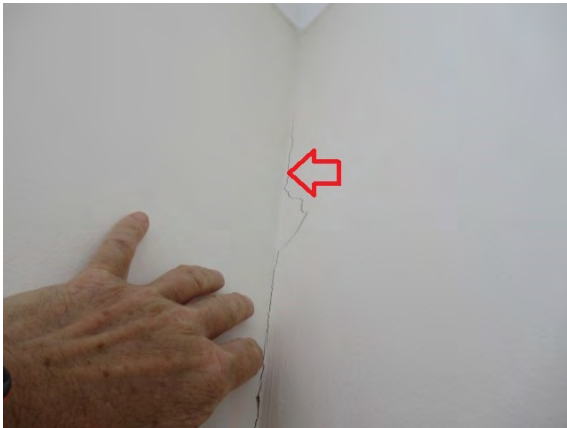
Condition	<p>No significant defects were noted during my inspection and the internal walls were found to be structurally sound.</p> <p>No evidence was seen of any cracking which might indicate that the property is subject to subsidence or unusual settlement.</p> <p>All moisture meter readings recorded around the property were found to be within a normal range indicating that, in those areas that could be accessed, it is not affected by rising or penetrating damp.</p> <p>Normal maintenance is required, including filling and redecorating cracks as necessary.</p>

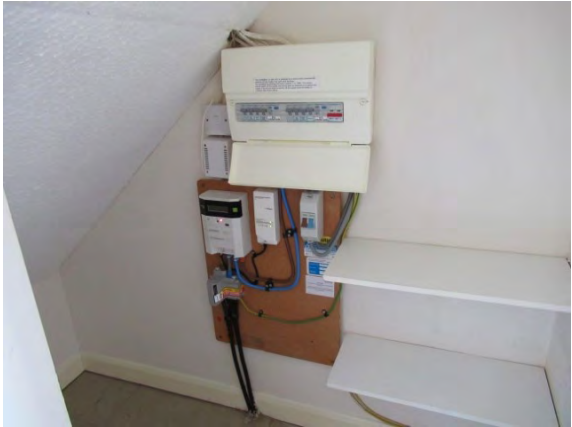
Consumer unit and meter

<p>Condition</p>	<p>No evidence of broken, loose or damaged parts of the installation was seen, nor were any obvious amateur alterations or interventions noted. However, where furniture and other items are present many of the outlets can be hidden from view.</p> <p>As far as could be seen the visible wiring is of a modern PVC type, and the nature of the consumer unit indicates that the installation has been upgraded in more recent years, though it is not known whether this included wiring within the walls, floors and ceilings..</p> <p>NAPIT recommends that domestic electrical installations are inspected and tested every 10 years in line with IET (The Institution of Engineering & Technology) Guidance Note 3 covering Electrical Installation Condition Reports (EICR). This guidance also recommends that at any change of occupancy (such as a house sale, or change of tenant) an Electrical Installation Condition Report is carried out to prove the installation to be in a satisfactory or unsatisfactory condition. This report should cover all the fixed wiring and equipment within the property boundaries, including outbuildings.</p>

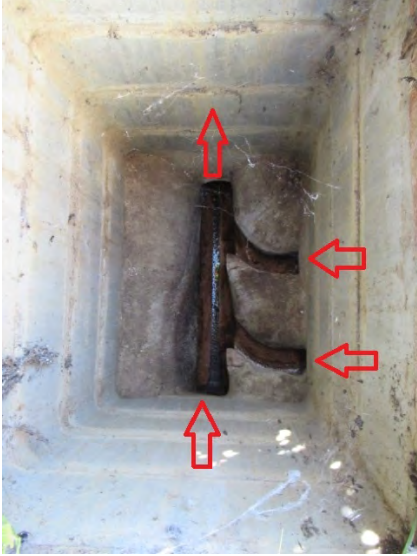
<p>Condition</p>	<p>Water was seen to run through the chamber with no blockages or undue levels of silt being apparent. The flow is from the house and forwards to the chamber at the front, whereupon it is directed to the left within a shared drain, presumably to a main sewer.</p> <p>Drains should be regularly inspected to ensure they remain free from blockages, tree root damage or other obstructions.</p>

<p>Inspection chamber in the front garden with the house to the right of the picture and the flow direction indicated</p>

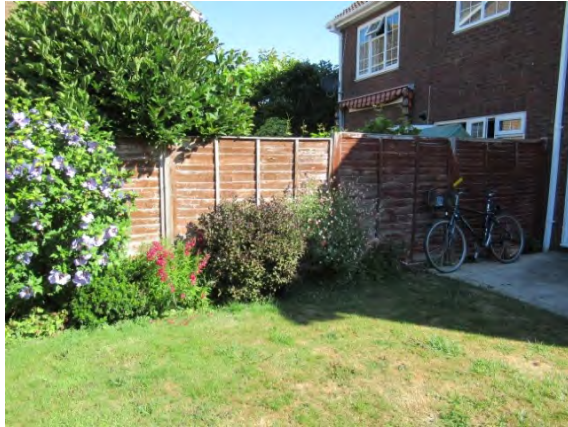
Boundary fence to the right side at the back is worn

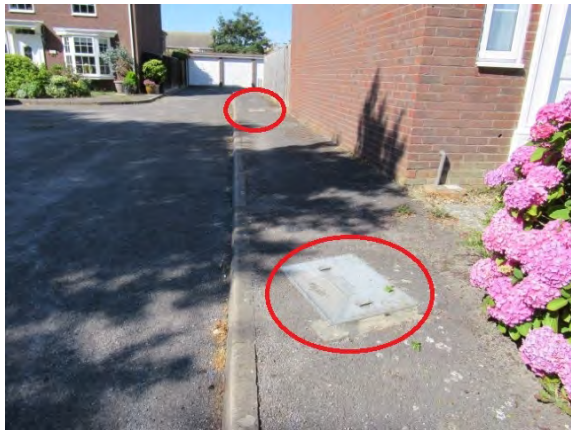
Raised manholes in the footpath to the left side
