PROPERTY SAMPLE SURVEY
NOT FOR DISTRIBUTION
EXAMPLE TEXT ONLY
AB12 3CD

SURVEY DATE 1 Sep 2018

BUY-TO-LET SURVEY REPORT

INCLUDING CONDITION and HEALTH & SAFETY REVIEW

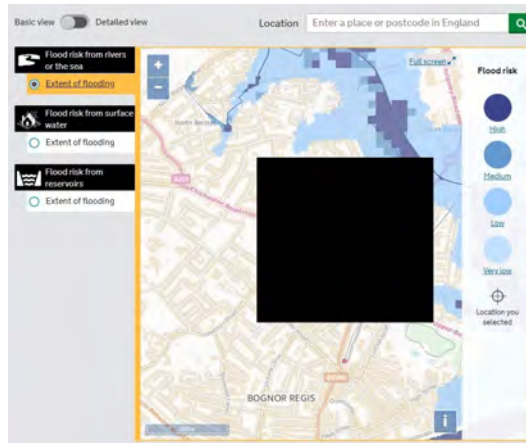
Flood risk low

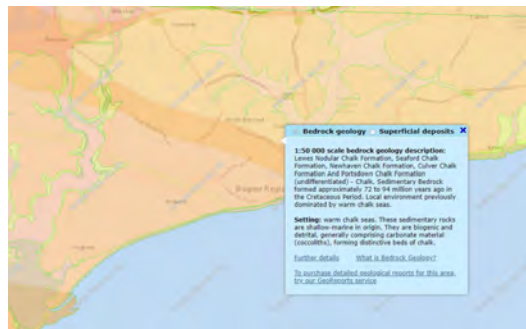
The property is located in an area where the ground is based on chalk.
 No evidence was seen of any cracking, or other disturbance, which might be linked to seasonal ground movement.

Chalk bedrock

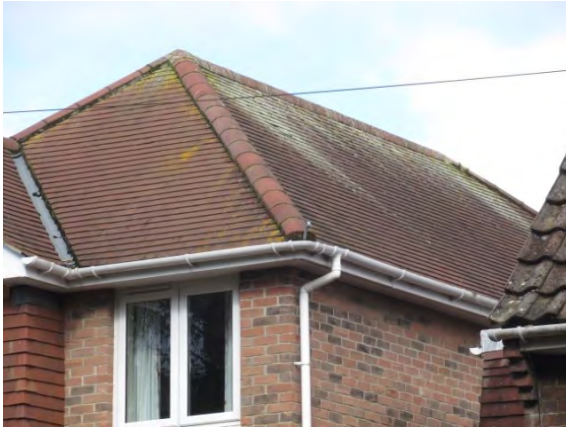
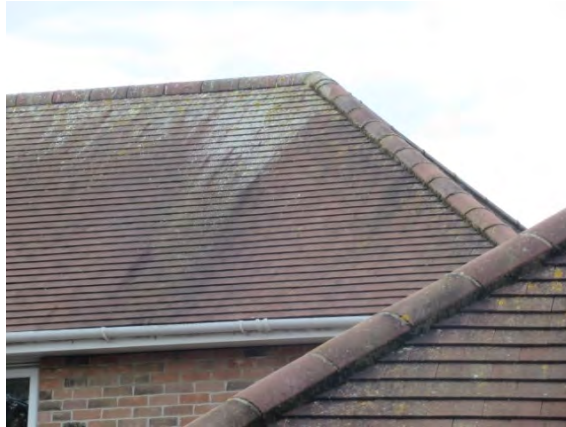
Condition	<p>No significant defects were noted and the roof was found to be structurally stable. No evidence was seen of unusual sagging or other movement which might indicate that the structure is failing.</p> <p>There are no significant numbers of slipped, missing or broken tiles visible on the roof pitches. Some moss growth was evident and this should be cleared as a matter of routine maintenance to prevent over-weighting the roof structure.</p> <p>The lead flashing that seals the polycarbonate roof of the rear living room extension has become dislodged to the right side and has been secured with tape. If not properly seated this will leak and so the flashing should be removed and reset. This may require complete replacement of the flashing. Although this is not major work, it should be carried out as soon as possible after occupation, and preferably before the next winter.</p> <p>Carry out normal maintenance including removal of moss build-up.</p> <p>Any slipped, missing or broken tiles on the roof pitches should be repaired and replaced.</p> <p>You should carry out a thorough visual inspection at least once a year, ideally in the Spring to identify and repair any damage that could have been caused by winter weather.</p> <p>Polycarbonate roofs, such as that to the rear, have a limited lifespan of, perhaps 10-20 years, and will require regular replacement.</p>

<p>Front and right side roof pitches</p>	<p>Right side roof pitch</p>
	<p>Loose and taped flashing for the living room extension roof at the back</p>	<p>Roof Elements</p>

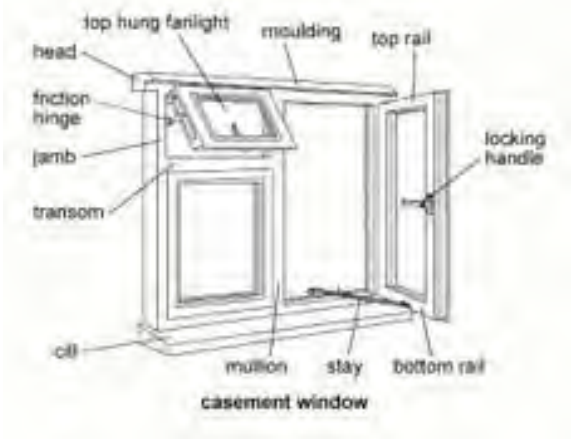
<p>Condition</p>	<p>No significant defects were noted and all of the windows and doors checked were found to operate normally.</p> <p>Under normal circumstances sealed double glazed units can be expected to last between 15-20 years before the seals, locks and hinges begin to fail. This can occur more quickly where windows are in exposed or vulnerable situations.</p> <p>The windows and doors are those installed at the time of construction of the property and so are around 7 years old.</p> <p>Normal maintenance of frames, hinges and locks is required.</p> <p>Be aware that previous owners may have distributed multiple sets of keys for the windows and doors to individuals not known to you. When purchasing a property you should consider the cost of replacing all of the door and window locks as soon as possible after you take up occupation. When doing this you should consult your insurers to ensure that you meet their requirements for security, and obtain any discounts that may be available by improving the security of the property.</p>

<p>Example of casement window style</p>

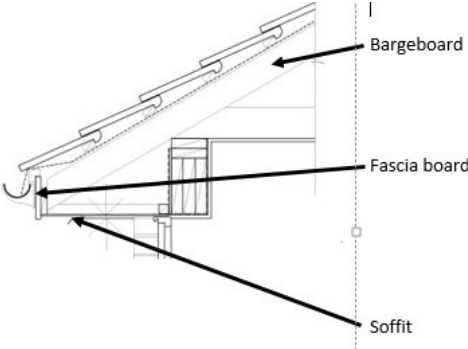
<p>Condition</p>	<p>No significant defects were noted.</p> <p>“Timbers” (including fascias, soffits and bargeboards) at the roof edges are made of uPVC and are in a serviceable condition.</p> <p>Normal maintenance is required which may include replacing dislodged fittings after severe weather.</p>

<p>External joinery detail</p>

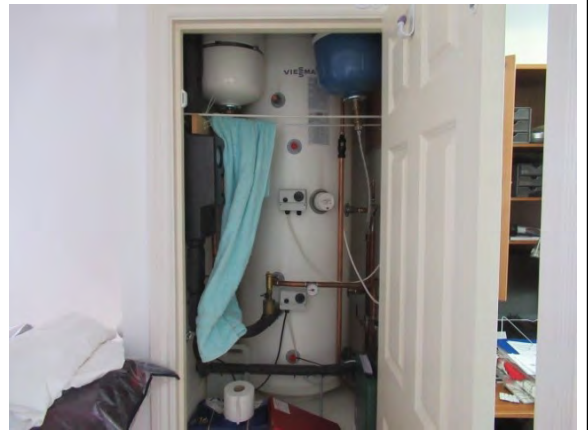
Hot water storage cylinder

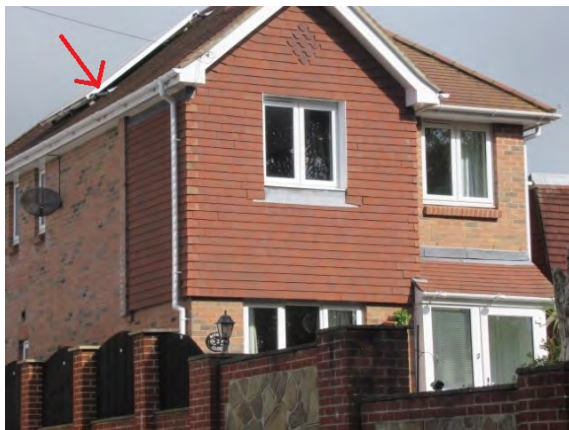
Solar water heating panels on the left side roof pitch

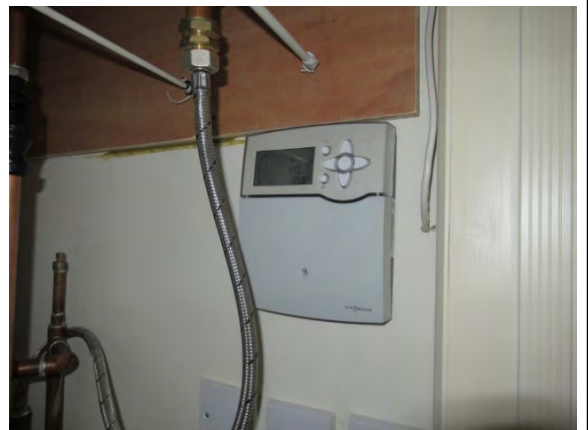
Control panel for the solar water heating panels

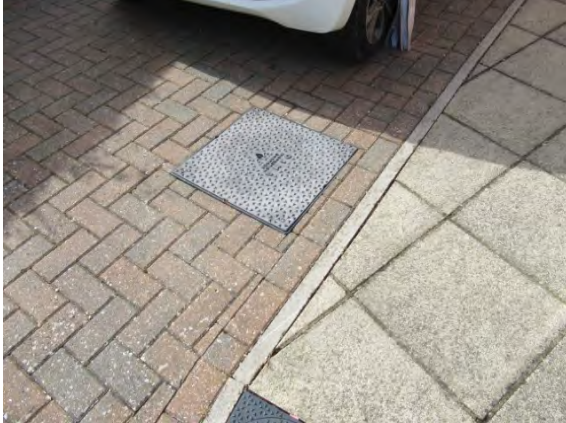
<p>Condition</p>	<p>Water was seen to run through the chamber with no blockages or undue levels of silt being apparent. The direction of flow was from the house, through the chamber in the drive, and out to the road, presumably to a shared sewer.</p> <p>It is often suggested that the manholes only allow inspection of 5-10% of an entire drainage installation. As such, it is entirely possible that damage can be present within the system but which would not be apparent from opening the manholes.</p> <p>The only way to confirm the condition of the whole installation is to commission a CCTV inspection from a qualified contractor, for example a member of the National Association of Drainage Contractors at www.nadc.org.uk/</p> <p>Drains should be regularly inspected to ensure they remain free from blockages, tree root damage or other obstructions.</p>

<p>Inspection chamber in the drive</p>

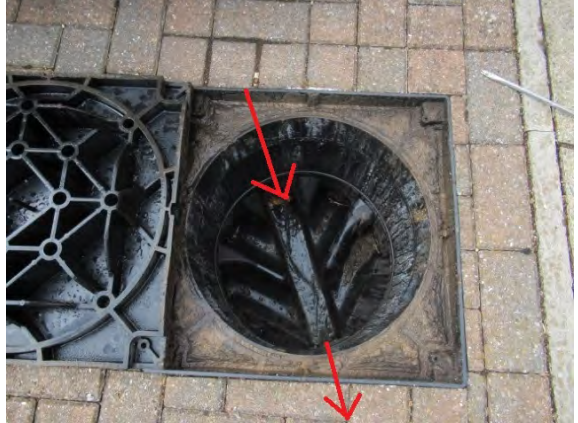
<p>Garage is to top of picture with the flow direction indicated</p>

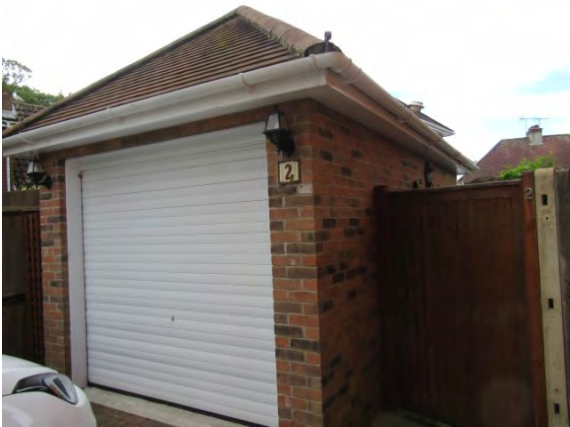
<p>Garage</p>

<h3 style="margin: 0;">7.1 Garaging</h3>	Condition rating	1
Construction & Type and Limitations	<p>The detached garage is brick built with a pitched and tiled roof. On the house side is a PVC personnel access door, and to the rear is an electrically operated metal roller shutter door.</p> <p>It was examined from ground level for signs of bowing or leaning of walls, damaged brickwork and pointing, internal defects, and the condition of the roof both internally and externally.</p>		
Condition	<p>The garage is in a stable condition with no evidence of any significant cracking or other unusual movement. Both doors were found to operate normally. Normal maintenance is required.</p>

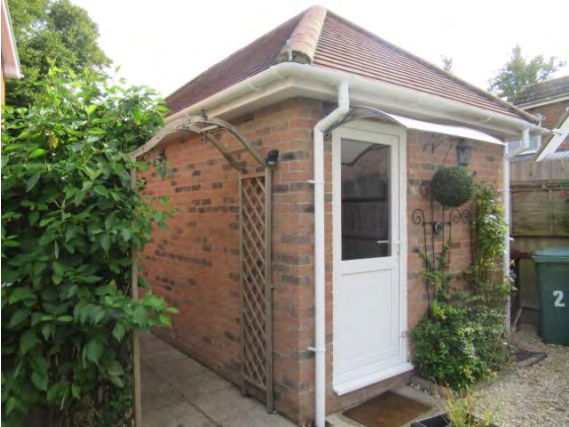
<p>Garage view from the house side</p>
