Mi HOME CONDITION SURVEY

HOME CONDITION SURVEY

PROPERTY 12 Anyroad Close
Sometown
AB12 3CD

SURVEY DATE 16 Jul 2018

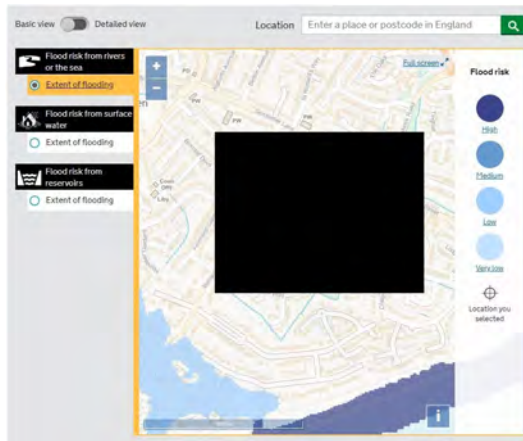
Note that flooding can occur outside of designated flood risk areas. The Environment Agency are constantly updating their data to reflect any new incidents of flooding or increased risks of flooding. You should consult your legal advisor to consider the options for carrying out a more comprehensive environmental search.

Flood risk low

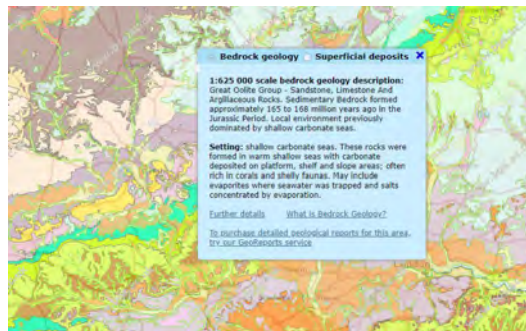
Bedrock

The property is located in an area where the ground is based on London clay.
 No evidence was seen of any cracking, or other disturbance, which might be linked to seasonal ground movement.

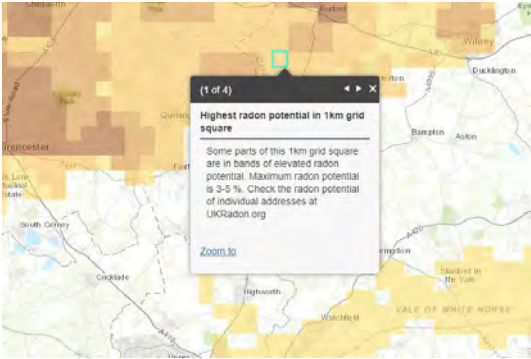
<p>Radon</p>	<p>The property is in a postcode area where medium levels of naturally occurring Radon Gas may be emitted from the ground. You should take the advice of UK radon, the reference site on radon from Public Health England at www.ukradon.org</p>

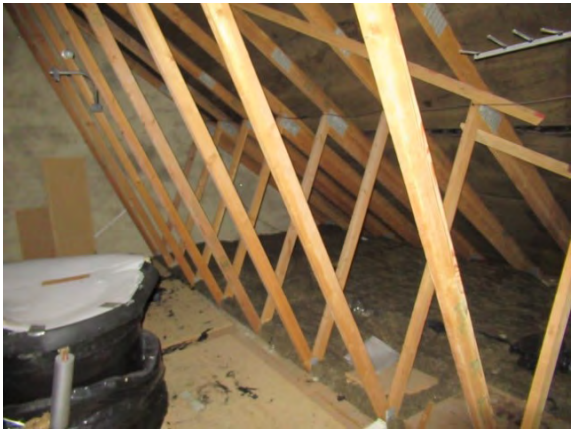
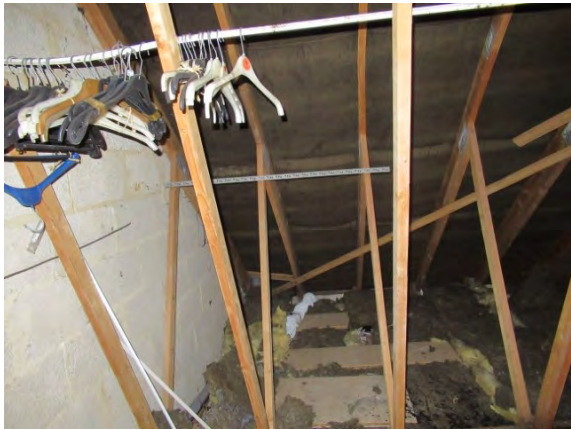
<p>Condition</p>	<p>No significant defects were noted during my inspection and the roof was found to be structurally sound.</p> <p>No evidence was seen of any unusual movement or stress of the supporting timbers within the roof, and there have been no obvious significant alterations to the structure which might have resulted in it becoming substantially weakened.</p> <p>Between the outer tile covering and the inner timbers is an underlining, sometimes called "sarking". It is present to provide an additional weather-proofing layer to moisture, snow and rain etc. that may be blown past the outer covering. In older properties it may not be present at all. Typically, in the 1920's the sarking is of timber planks. Later properties often have a layer of bituminised felt, while in modern properties a breathable membrane, such as Tyvek, is normally used. In this case the sarking is of bitumen felt. It was found to be in a mostly undamaged condition and is considered to be suitable for its purpose.</p> <p>Other than in those areas which have been boarded, the roof space is laid with approximately 200mm of wool type insulation at joist level. This is close to the current recommendation of 270mm for maximum energy efficiency. It does, however, limit movement and storage within the roof space as any supporting joists are concealed.</p> <p>High moisture levels within roof spaces are responsible for the promotion of the development of timber defects such as rot and infestations by wood boring insects (commonly known as woodworm). Wood moisture content readings taken were found to be well within normal limits and below the levels normally required for this type of defect.</p> <p>Care should be taken when moving around, or storing heavy objects, in the roof space. The spaces between the floor joists will not support a person's weight, or that of large boxes etc. Where heavy items are to be stored it is important to distribute the weight evenly using fixed boards. Additional structural support may be required if you plan to store large quantities of heavy items in the roof space.</p>

<p>Looking towards the right</p> <p>Looking towards the left rear</p>

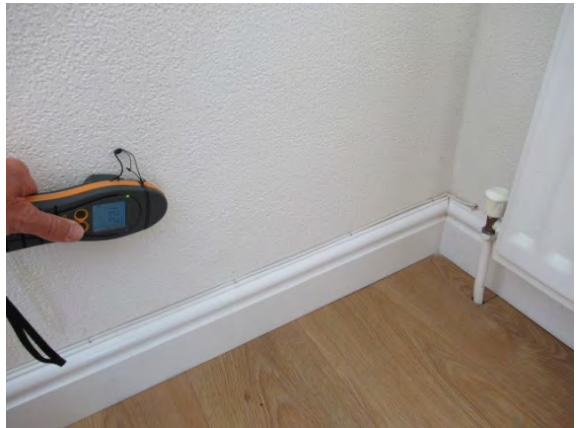
Condition	<p>No significant defects were noted during my inspection and the internal walls were found to be structurally sound.</p> <p>No evidence was seen of any cracking which might indicate that the property is subject to subsidence or unusual settlement.</p> <p>All moisture meter readings recorded around the property were found to be within a normal range indicating that, in those areas that could be accessed, it is not affected by rising or penetrating damp.</p> <p>Normal maintenance is required, including filling and redecorating cracks as necessary.</p>

<p>A photograph showing a hand holding a moisture meter against a white wall. The meter's display shows a normal reading. The wall is near a white baseboard and a wooden floor.</p>

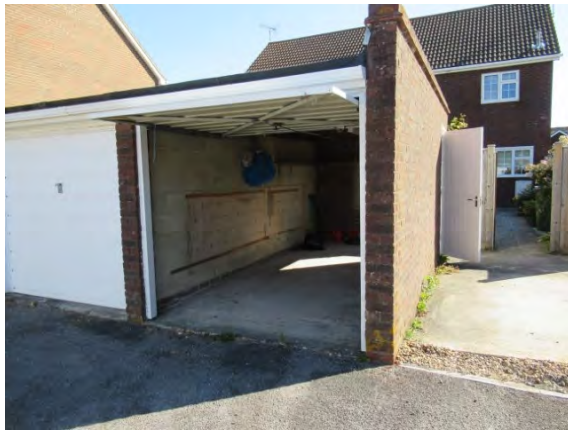
Garage

Condition	<p>The garage was found to be in a good condition with no obvious significant defects. Both doors were found to operate normally.</p> <p>It is understood that the roof covering was replaced by the present owner in approximately 2013, and no evidence of leaks or other failure were noted.</p> <p>Normal maintenance, including regular retreatment of the walls, is required.</p> <p>Foliage and debris should be removed from the outside walls.</p> <p>Compared to traditional coverings such as tiles and slates, most felt roofs have a typical life of 10-25 years. They are also prone to sudden failure and leakage. Periodic re-covering will therefore be necessary. When this is undertaken, the supporting structure may also need some attention.</p>
------------------	---
